Solving structure borne noise problems from car wash facility

Jorge Torres^{1*}, Anders Buen²

^{1,2} Brekke Strand Akustikk AS, Oslo, Norway.

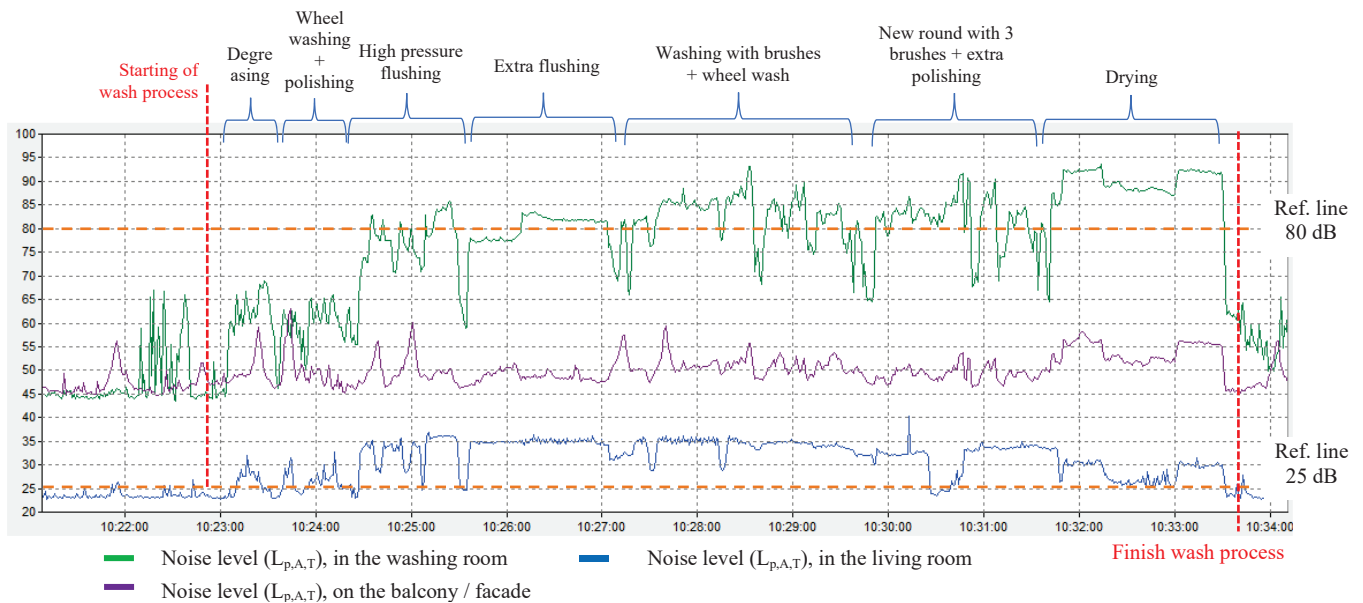
Figures below show results from noise and vibration measurements in the car wash and in the apartment before mitigation measures. A reference line at 25 dB and 80 dB is shown in orange in all figures. Figure 3 shows noise measurements in the car wash and the apartment. The noise level in the apartment (blue curve) increases from $L_{p,A,T} = 22-23$ dB (background noise) after the washing process started, and it is approximately constant around 35 dB through all washing process. Lower values were registered in the last part of the washing (drying of the car), but the noise level is also above the requirement.

Figure 3: Noise measurements in the car wash and in the apartment, living room.

On the other hand, it was also measured the vertical airborne sound reduction from washing room to the apartment. The result from measurements was $R'_w = 65$ dB and it is not enough to reduce the airborne noise from the washing room. Noise level in the washing room was measured to $L_{p,A,T} = 83 - 93$ dB, see Figure 3. This means that part of noise measured in the apartment is airborne.

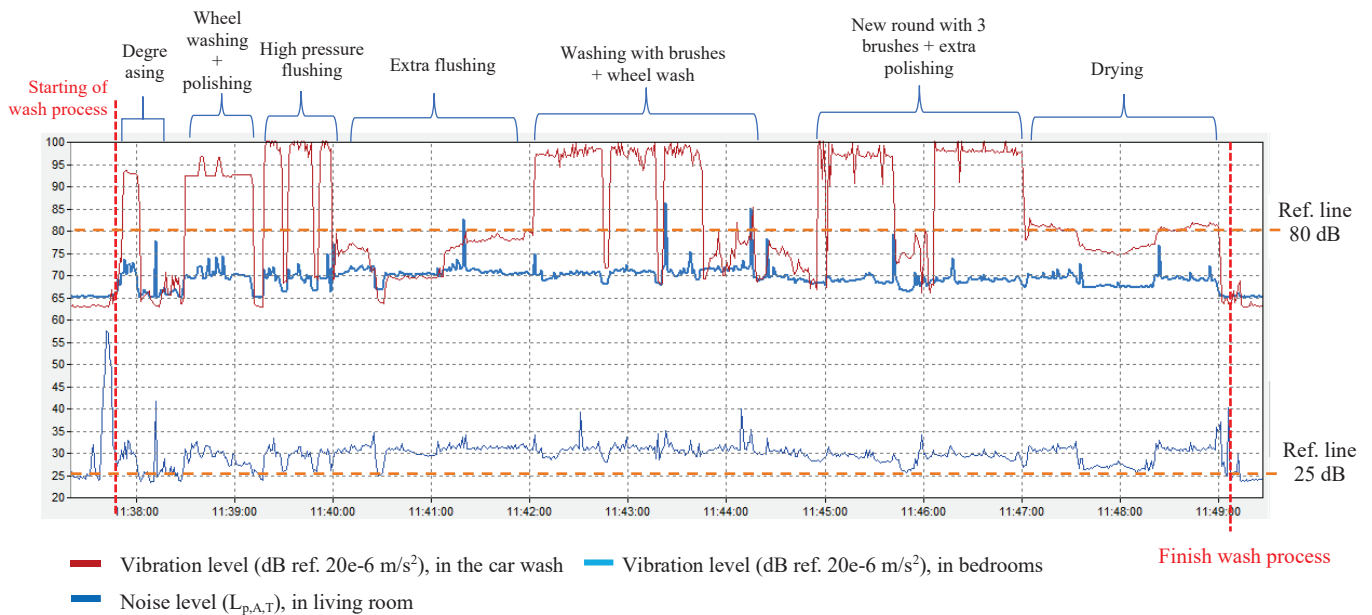
Figure 4 shows vibration and noise measurements in the apartment while a car is being washed. The vibration level in the apartment (light blue curve) increases when pumps in technical room are activated (brown curve). The measurements show that the noise is mainly transmitted as structure borne noise.

Figure 4: Noise and vibration measurements in the technical room and in the apartment, bedroom.

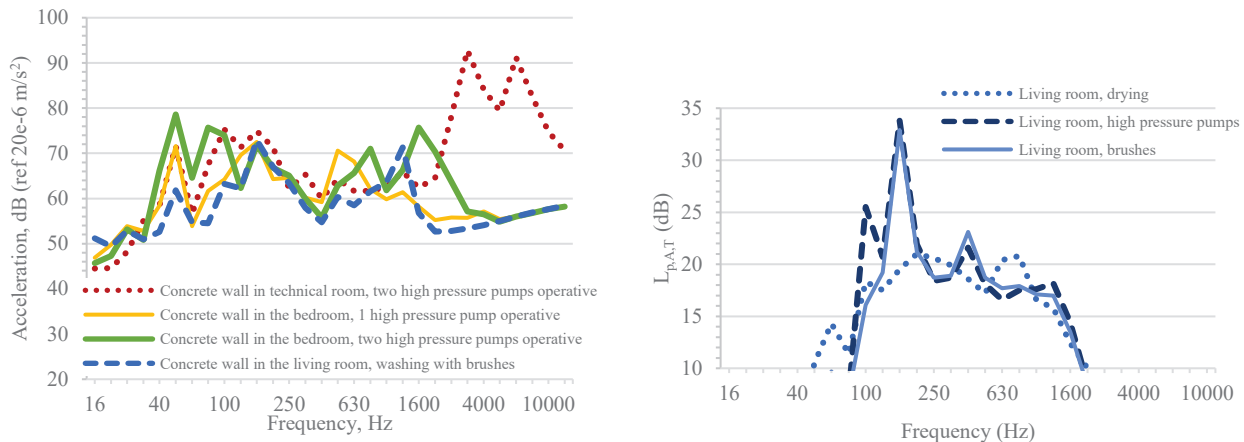
Figure 5 shows the frequency spectrum from vibration measurements. It was measured on the concrete walls in the technical room (dot red line), in the bedroom (yellow and green line) and in the living room (dash blue line). The results show that fundamental frequency from high pressure pumps (48.8 Hz) is propagated via concrete walls and radiated from the floor and walls into the apartment. The spectrum from noise measurements in the living room shows harmonics components at 100 Hz and 150 Hz when high pressure pumps are operative, it means, the sound energy is structure borne noise transmitted to the apartment.

Figure 5: Spectrum from vibration (left) and noise measurements (right).

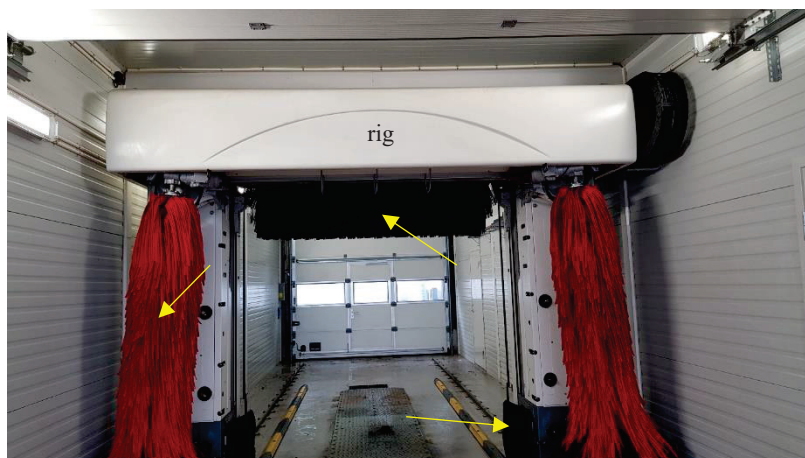
Figure 6: Washing room

The car wash has two vertical washing brushes, one horizontal washing brush, and two-wheel brushes on the sides. Figure 6 shows the brushes with yellow arrows. Each brush is connected to a motor that run at 1400 rpm (23.3 Hz).

The space between sandwich element and concrete floor was approximately 20 mm. Such as, it was not possible to improve vertical sound reduction. Sound computation was done with the software for room acoustics, ODEON. As mitigation measure, the ceiling and approximately 50 % of the wall inside washing room were covered with absorber plate, sound absorption class A, type Loke™ strong 40 mm.

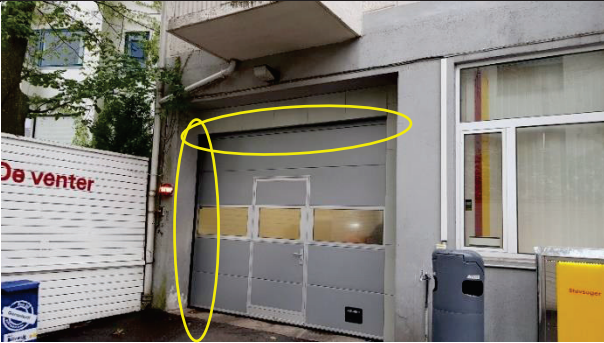
The car wash gate is a rolling gate, model Crawford OH 1042P. This gate is made with steel and aluminium, and it has a thickness of 42 mm filled with CFC polyurethane foam. It was done sound measurements according to standard ISO 16283-1:2014 [6]. Sound measurements show that gate has an airborne sound reduction of $R'_w = 23$ dB. This agrees with producer datasheet. A reduction of 23 dB is not enough to attenuate noise from the car wash facility. The results also show weakness over 400 Hz in the sound reduction. During the inspection, it was observed sound leaks around the gate. It was sealed spaces around the gate with elastic rubber.

<p>The car wash gate had sound leaks around.</p>

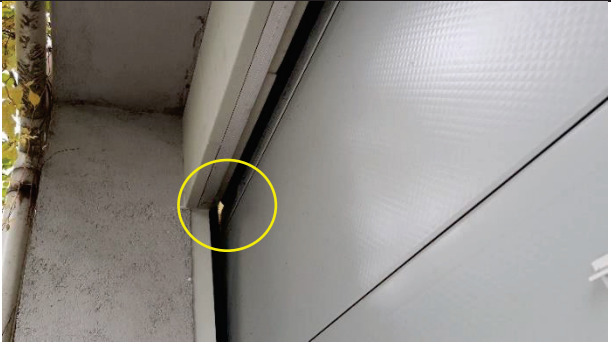
<p>Sound leaks were sealed with elastic rubber, but there is still a small leak on the corner.</p>
2

Noise level for almost all washing processes is below the noise requirement now. There are still sound leaks on the corner of the gate, and this may be the reason why the noise level is 2 dB above the requirement.

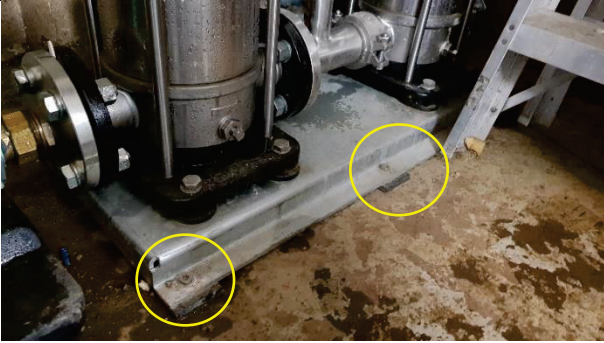
The high-pressure pumps were screwed to the foundation plate with neoprene vibration isolators. This method does not provide sufficient vibration isolation of low-frequency noise. In addition, some water pipe from pumps were fastened with plastic supports and other were fastened with rubber clamps, but it was rigid connected the concrete walls. Vibration transmission from water pipes to the apartment was identified.

<p>High-pressure pumps were screwed to the foundation plate with neoprene vibration isolators.</p>

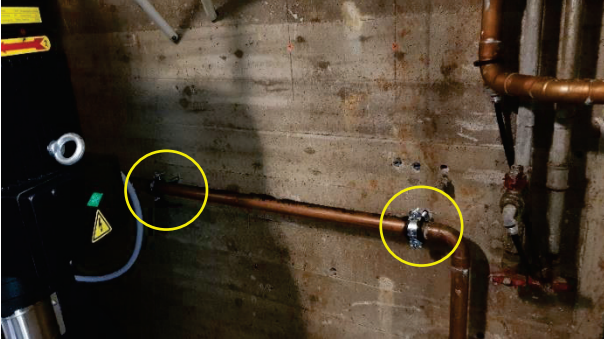
<p>Water pipes connected to high-pressure pumps were rigidly fastened with clamps.</p>

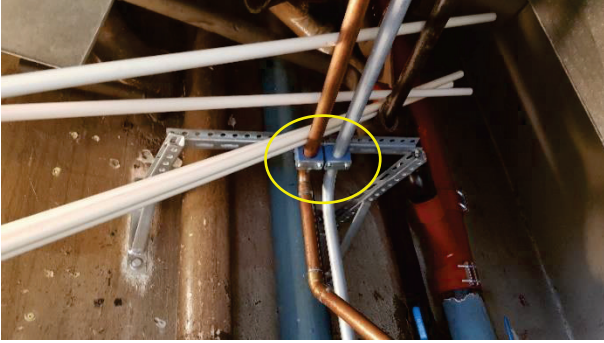
<p>Water pipes connected to high-pressure pumps were attached with plastic.</p>

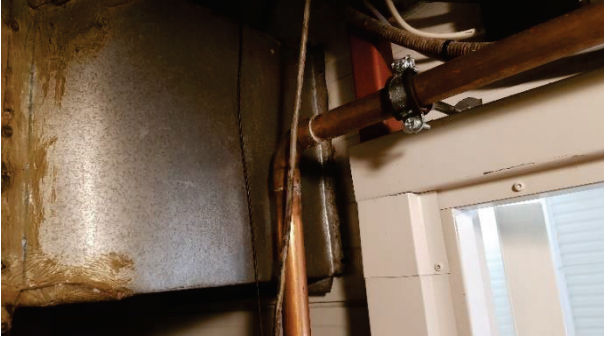
There was an exhaust ventilation duct located close to the sandwich elements in the technical room. This was used to extract air in the ground before the car wash was installed. It was checked whether the duct was connected to the vents in the bedroom in plan 1. After some studies, it was found that the air extraction in the building was changed to mechanical from the roof. Thus, the ventilation duct was cut and sealed with acoustic panels.

<p>There was a ventilation duct in the technical room which was connected to exhaust air system in the bedroom (plan 1).</p>
